# DRYSCAN

Infrared Inspections

DryScan Limited was engaged to complete a Pre-Purchase Scan only moisture ingress thermal imaging inspection for Joe Blogs at 8 Anywhere, Auckland.

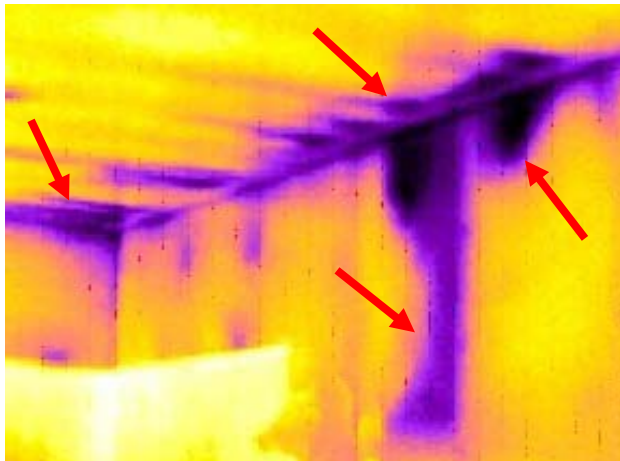
This image shows a significant difference and inconsistent distribution in colour / temperatures which would indicate the presence of a thermal anomaly and would require further investigation.

Here the internal wall framing is visible, with warmer areas being highlighted in yellow and colder areas in purple.

The colder / purple areas in the upper corner would be an area of concern and a recommendation for further investigation would be expressed.

NOTE: The purple colour is not always an indication of moisture as the colour is dependant on the ambient conditions. Moisture can also be indicated by a lighter shade of colour.
